# Manhole Inspection Summary

Manhole # S29K\_\_021MH

Insp Date: **4/9/09 12:40 PM**

**Location** Address: **720 PORTLAND ST**

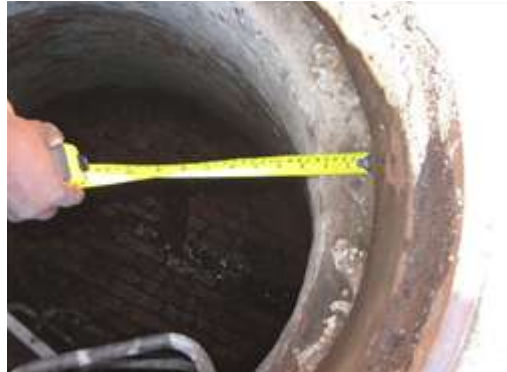
Defect 3

Offset: **2** (in.)

2 INCH OFFSET

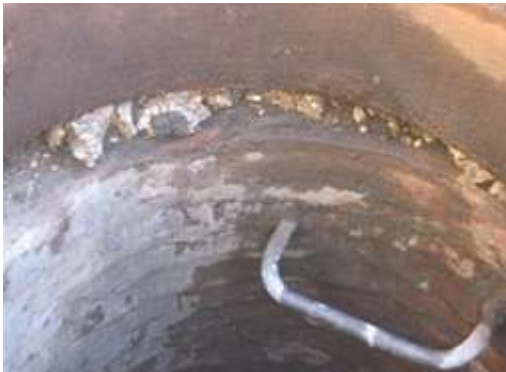
Defect 1

Condition: ☐ Sound ☐ Cracked ☒ **Leaks**

Condition: ☐ Sound ☐ Cracked ☐ Root Intrusion ☐ Loose Brick ☒ **Deteriorated**

LID/FRAME INFILTRATION AND  
DETERIORATION

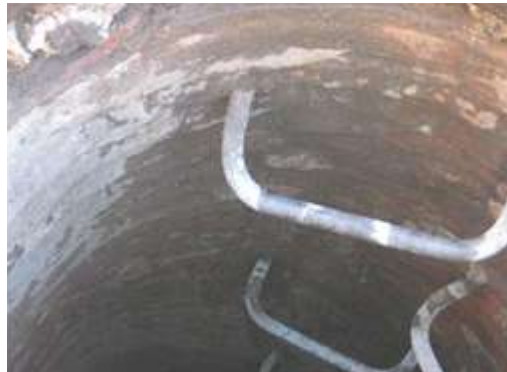
Defect 2

Infiltration: ☐ None ☒ **Joint** ☐ Cracks ☐ Mortar ☐ Roots ☐ Wall

JOINT INFILTRATION
